Manhole Inspection Summary

Manhole # S35M__004MH

Location Address: **600 light st**

Cross Street: **key highway**

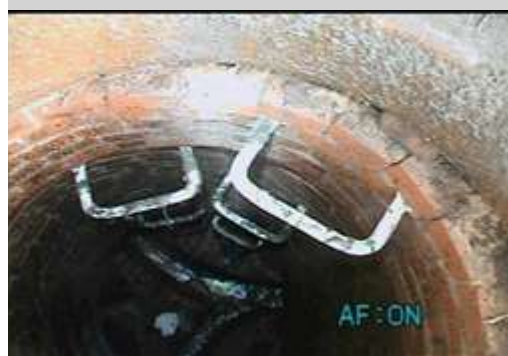
Defect 3

Bench debris

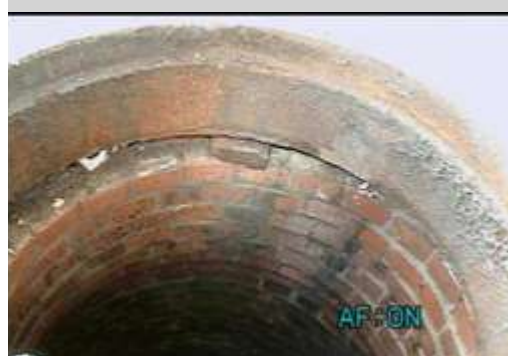
Defect 1

Chimney cracks and deteriorated, offset

infiltration from frame

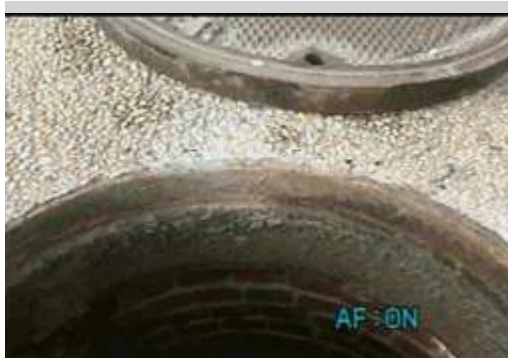
Defect 5

cracked cover and Worn Frame where
ponding occurs

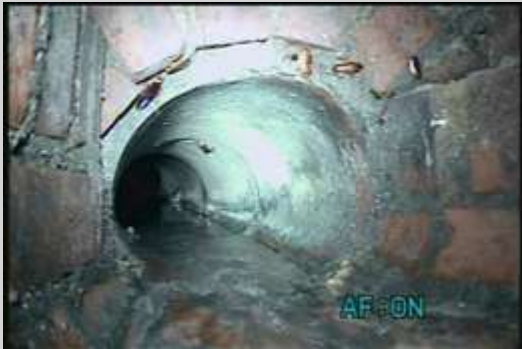
12 O'Clock Outflow

8 in. Circular Gravity Sewer
Pipe Out @ 12 O'Clock

Deposits: ☒ None ☐ Mud ☐ Sludge ☐ Debris ☐ Grease

Infiltration: **None** Pipe Seal Cond: **Unknown**

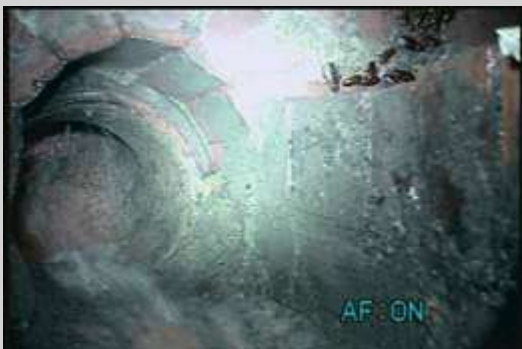
3 O'Clock Inflow

8 in. Circular Gravity Sewer
Pipe In @ 3 O'Clock

Deposits: ☒ None ☐ Mud ☐ Sludge ☐ Debris ☐ Grease

Infiltration: **None** Pipe Seal Cond: **Unknown**

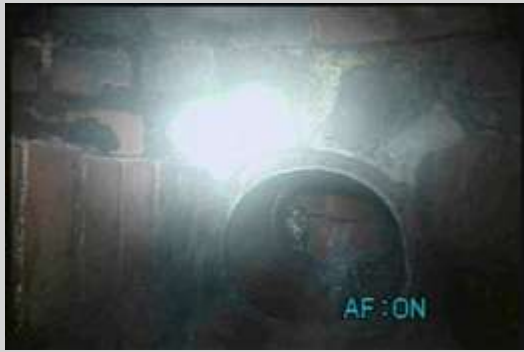
7 O'Clock Inflow

Pipe In @ 7 O'Clock

Deposits: ☒ None ☐ Mud ☐ Sludge ☐ Debris ☐ Grease

Infiltration: **None**
